# ePS Network Services

## Release Notes

**Version 4.1.1**

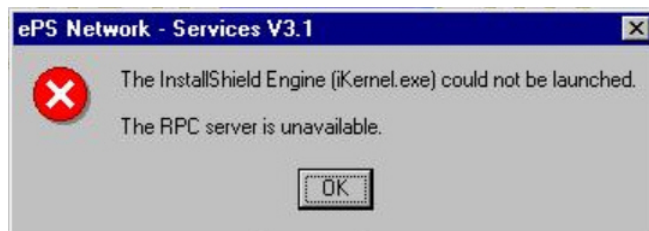
The automatic installation of the ePS Network Services by copying the setup.exe to D:\Install on a PCU does not work. When the PCU starts, the installation aborts with the following error message:

If Internet Explorer 5.5 has already been installed on the PCU, the error does not occur and the installation runs without error.
