1768 CompactLogix Controllers, Revision 20

CompactLogix Catalog Numbers 1768-L43, 1768-L45

Compact GuardLogix Catalog Numbers 1768-L43S, 1768-L45S

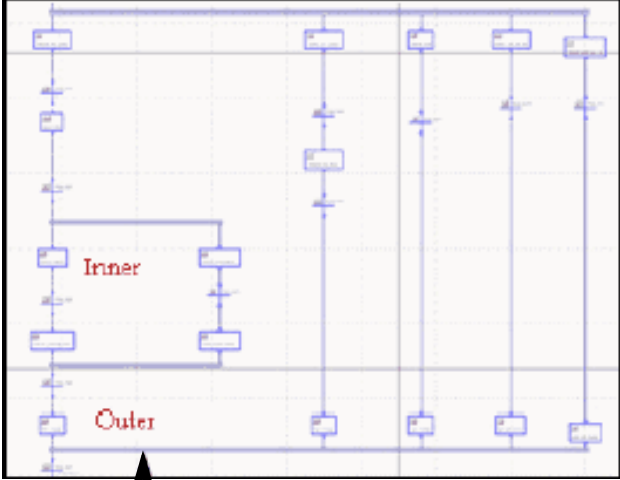
Cat. No.	Description
1768-L43, 1768-L45, 1768-L43S, 1768-L45S	<p>CORRECTED: An anomaly can occur when you nest simultaneous branches in a Sequential Function Chart (SFC) routine as shown below.</p>

<p style="text-align: center;">Bottom-most Steps</p> <p>During normal operations, the logic does not step out of a simultaneous branch until all of the incoming legs have reached their bottom-most step. In the example shown, the logic does not step out of the Outer simultaneous branch until the leftmost leg has stepped out of the Inner simultaneous branch. The first time through the SFC routine, the application works as expected. On subsequent scans, however, the chart steps out of the Outer simultaneous branch even though the left leg has not reached the Inner simultaneous branch yet.</p> <p>This behavior occurs because the information in the bottom step, that is, the step next to the word Outer, remains from the previous scan. This stale information incorrectly causes the transition to move on as if the left leg is at the bottom step when it actually is not.</p> <p>To work around this anomaly, confirm all of the incoming legs have reached their bottom steps in the transition. You can check the .x bits to make sure the bottom-most step of each converging leg is active before allowing the chart to advance. This check can be added to the transition logic already present.</p> <p>For example, the steps in the following expression are the bottom steps (see graphic above) of the incoming legs. Each step has a timer. The transition does not move on until all of the step timers have reached their preset value.</p> <p>The expression can be modified to be sure those steps are truly active. This is the original expression:</p> <pre>// Unit is ready to Transition Step1_ready.dn and Step2_ready.dn and Step3_ready.dn and Step4_ready.dn and Step5_ready.dn</pre> <p>This is the modified expression to work around this anomaly.</p> <pre>// Unit is ready to Transition Step1_ready.x and Step2_ready.x and Step3_ready.x and Step4_ready.x and Step5_ready.x and Step1_ready.dn and Step2_ready.dn and Step3_ready.dn and Step4_ready.dn and Step5_ready.dn</pre> <p>IMPORTANT: The x bit is cleared when the chart transitions out of a step.</p> <p>Adding this check to the condition forces the engine to wait until all of those steps are genuinely active before advancing out of the simultaneous branch.</p> <p style="text-align: right;">Lgx00118188, Lgx00116506</p> <p>CORRECTED: Applications that have a large quantity of HMI tags on scan in the controller can experience a non-recoverable major fault when doing online edits.</p> <p style="text-align: right;">Lgx00118192, Lgx00115817</p>

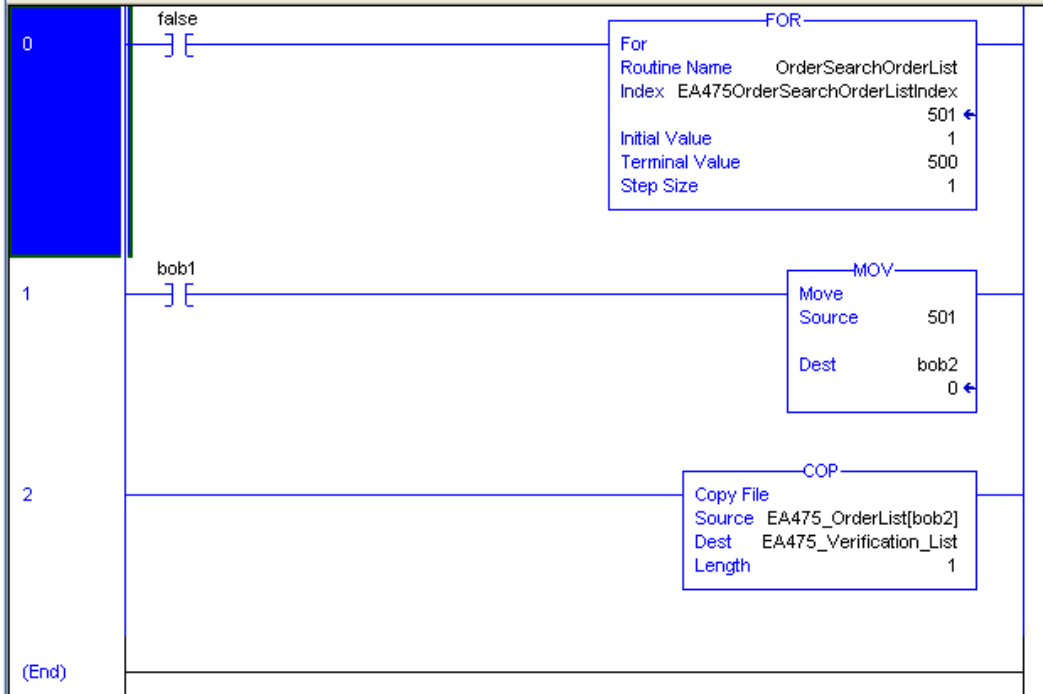
Cat. No.	Description																														
1768-L43, 1768-L45, 1768-L43S, 1768-L45S	<p>CORRECTED: If a FOR instruction is scanned true and an instruction has an index out of range that references a UDT or multi-dimensional array, the controller will fault. Clearing the fault and returning to run mode will cause a nonrecoverable major fault.</p>
